## Battery Drain Fix for 916Mhz wireless cabs

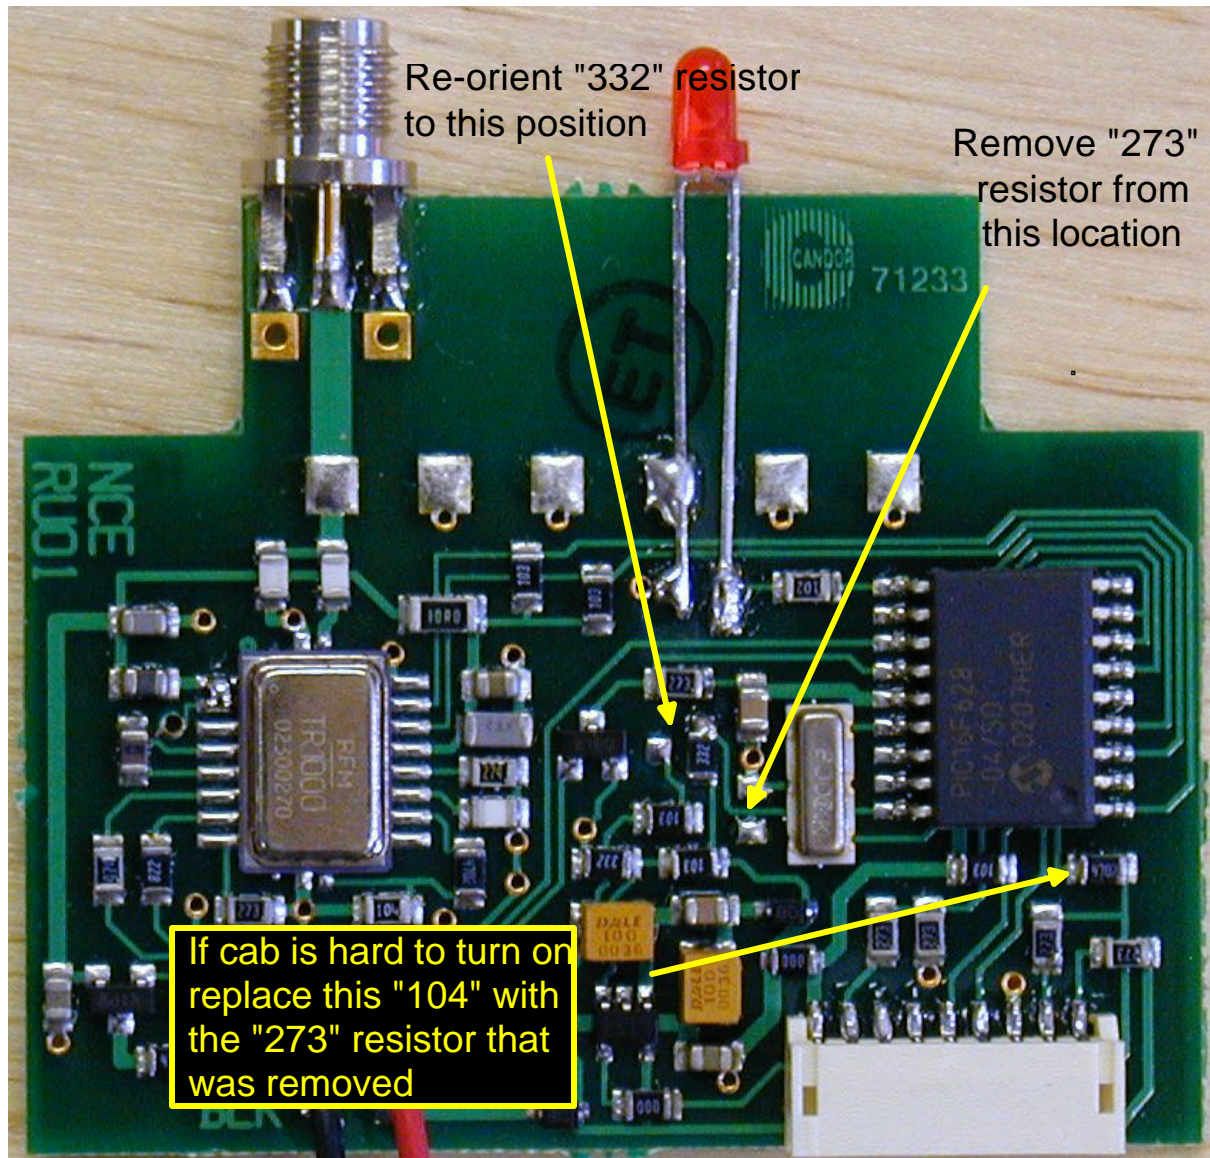
Procab batteries can be drained by the very circuitry we put in to save them. By removing one resistor and re-orienting another you can considerably lengthen the battery life. This fix will solve the problem of the missing clock (replaced by the text "LESS 1.0") in the upper right on the ProCab LCD display. The resistors are in the low voltage detection circuit of the radio board. They are not needed for normal operation of the cab.
